AUSSIE TRAVELLER PTY LTD

Checking your Door Lock Operation

I00095A1/2

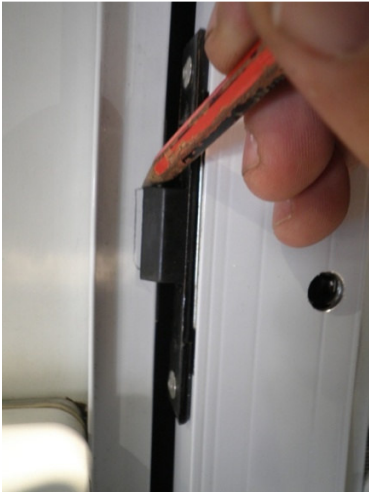
Fig4

6. Now close your door against the frame and with a pencil trace around all plastic tongues. Fig 4
7. Check all the plastic tongues have a minimum 2mm clearance in the hole on the edge of the door frame (Fig5). Adjust if required.
8. Check all the plastic tongues can go in the depth required (Fig6). Adjust if required.

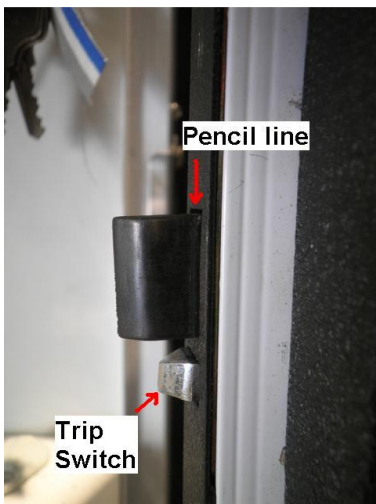
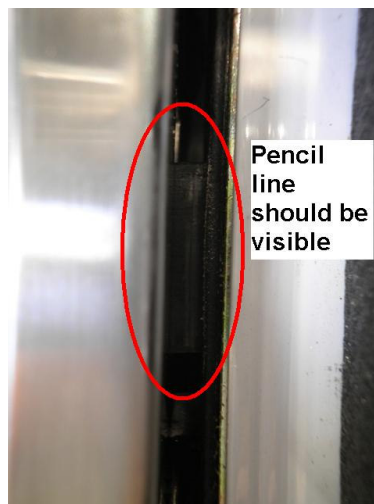
***If the trip switch is **not pushed in enough** by striker plate it will not allow the door to be locked.

9. Check the trip switch is contacting frame by enough to see the pencil lines on the plastic tongue.
Fig 7 & 8 . Adjust if required.

- Note – Improperly fitted doors and can lead to reliability problems or early failure of lock mechanism. This is not a door failure but a fitting issue resulting in lock failure.
