AUSSIE TRAVELLER PTY LTD

Checking your Door Lock Operation

I00095A1/2

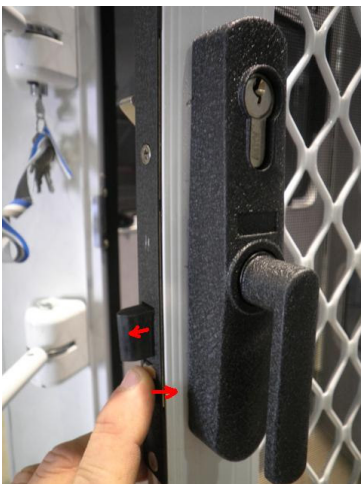
1. Separate inner door and outer door.
2. Lock your door outside the frame.
3. Press the silver trip switch just below main plastic tongue. Main plastic tongue will pop out to extend out further. Fig1
4. Turn handles outwards. Top and bottom tongue will extend out of door. Fig2
5. Turn the barrel and lock the door. You should hear a solid click. Fig3
Your door is now locked outside of the frame. The tongue on the edge of the door will not want to go back in now.
